Pilot Flies R44 to Safety After Losing Tail Rotor

Richard Hayes of Southern Lakes Helicopters did some remarkable flying when he piloted his Raven II to a safe landing after the helicopter's tail rotor was destroyed.

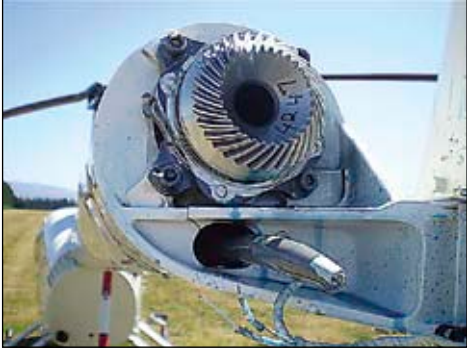
Hayes was flying with doors off at about 4500 feet and 100 knots on a venison recovery operation in New Zealand's Fiordland National Park when something exited the helicopter and destroyed the tail rotor and tail rotor gear box.

Little remained of the tail rotor and tail rotor gear box following the accident.

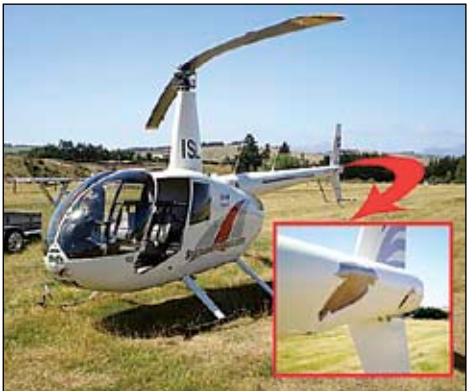
The R44 Raven II's tail rotor was destroyed, but the empennage remained intact.

The R44 features a large vertical stabilizer to equalize the torque of the main rotor and to help control the helicopter in the event of a tail rotor failure - the scenario Hayes faced. Without the empennage and tail rotor, the helicopter would have spun uncontrollably.
